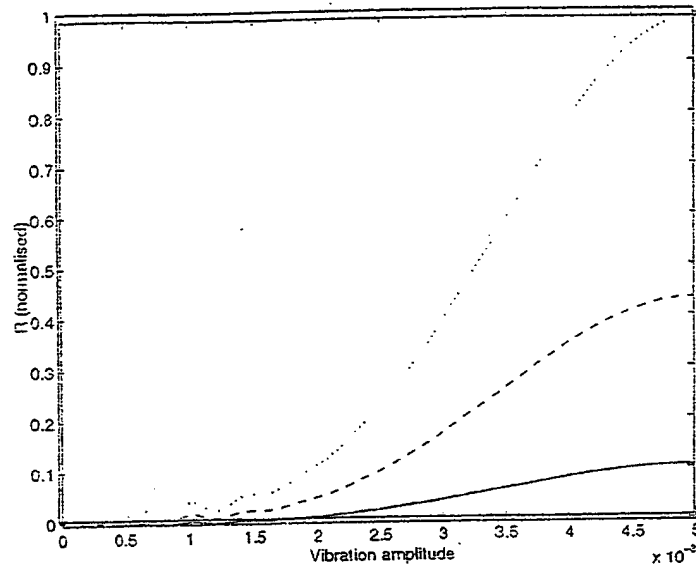
Figure 3 Simulated (normalised) power Doppler versus vibration amplitude for $A = 0.1$ (solid), $A = 0.2$ (dashed) and $A = 0.3$ (dotted). Parameters were as for Figure 1 with the exception of vibration frequency which was $f_v = 40Hz$.

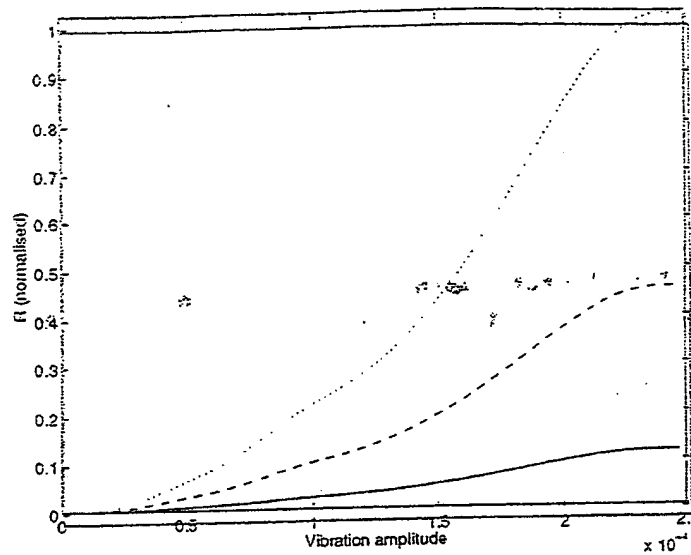
Figure 4 The previous Figure with the abscissa scaled.
